## Hip resurfacing arthroplasty complicated by mismatched implant components

Alessandro Calistri, Patricia Campbell, Catherine Van Der Straeten, Koen Aimè De Smet

**Key words:** Hip resurfacing; Mismatch; Revision

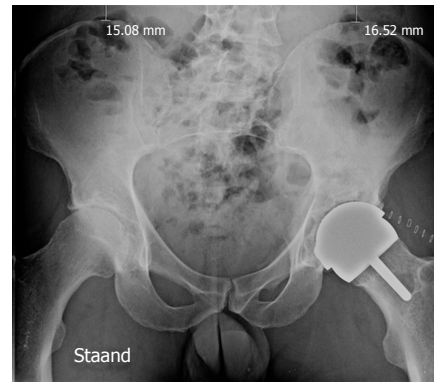
In July 2007, a 51 years old man was admitted at the ANCA Medical Centre in Gent with a mismatch of implants. Three days prior, at another hospital, the patient underwent a resurfacing arthroplasty for osteoarthritis of the left hip, with a posterior approach assisted with computer navigation (Brainlab®). A Birmingham Hip Resurfacing (Smith and Nephew, Memphis, Tennessee) was used. In the recovery room, the patient complained of severe pain and a rigid immobility of the hip that did not disappear the day after surgery. The patient at clinical examination presented a flexion contracture on the right side and pain in the groin. X-rays confirmed a mismatch between the femoral and the acetabular component diameters (Figure 1). A size 56-mm cemented femoral component was combined with a size 62-mm cementless

Figure 1 The post-operative X-ray, showed a mismatch between the femoral and the acetabular component diameters.

acetabular component thick shell that should have been applied with a 54-mm head instead of a 56-mm head.

The patient was treated with a revision to total hip arthroplasty two days later with the same posterolateral approach. The femoral component was revised with a Profemur L stem (Wright Medical Technology, Arlington, Tennessee, United States) and the socket was replaced by a Pinnacle™ Acetabular Cup System (DePuy Orthopaedics, Inc., Warsaw, United States) with Delta on Delta BioloX Ceramic couple 36 mm. Routine post-operative thrombo-prophylaxis was carried out. He experienced no pain and was allowed full weight bearing the day after revision surgery. The patient experienced an ordinary postoperative course and was habitually followed up in outpatient clinic.

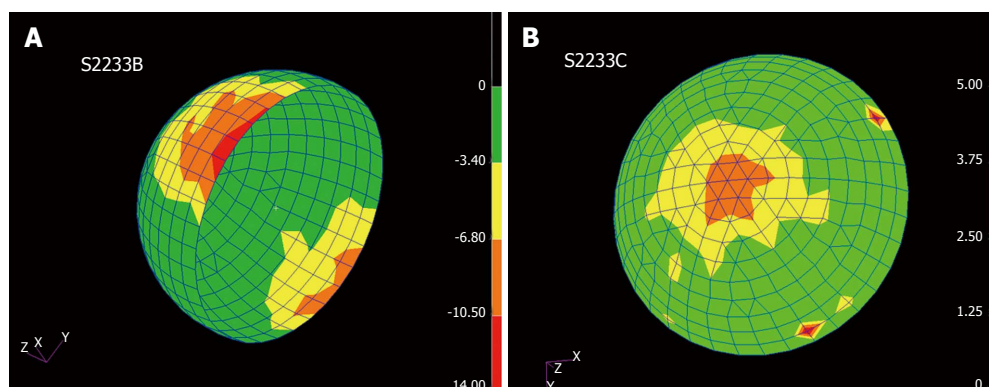
The implants were analysed using a coordinate measuring machine to measure both components. This confirmed the size mismatch; the femoral component was 55.75 mm while the acetabular component was 54.054 mm. The coordinate measuring machines (CMM) map indicated damage to the femoral component (Figure 2). The effect of the mismatched sizing is demonstrated by comparing the removed components to a correctly sized set using a 54-mm femoral component obtained from the retrieval lab (Figure 3).

Figure 2 Coordinate measuring machines wear measurement of the mismatched couple showed that the femoral component had already been damaged.

Coordinate measuring machines (CMM) wear measurement of the mismatched couple showed that the femoral component had already been damaged.

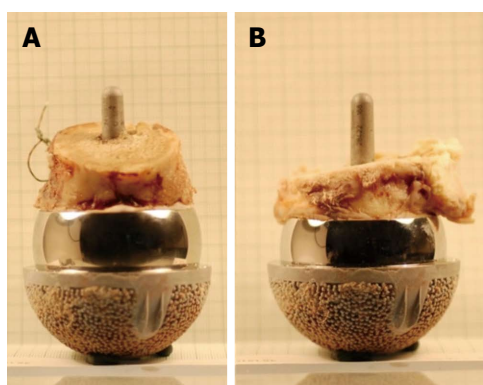
Figure 3 The 62-mm cup mismatched with and 56-mm head and but correctly matched with a 54-mm head. A: Mismatched couple with 62-mm cup and 56-mm head. Note how the femoral head was not fully seated in the socket by 3 to 4 mm. Compared to B; B: The same 62-mm thick shell cup correctly matched with a 54-mm head.

the case. The thin shell component, cup size 62-mm was requested but the 62-mm thick shell which can be used only with a 54-mm head was mistakenly provided instead. This thick shell is a special acetabular component that can be used for particular cases of head/neck mismatch or hip articulation deformity such as coxa profunda and protrusion acetabuli.
