## Basilic vein variation encountered during surgery for arm vein port: A case report

**Specialty type:** Medicine, research and experimental

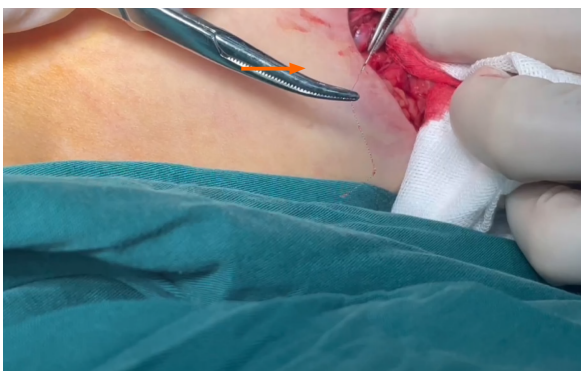
**Figure 2 Abnormal guidewire about 1.8 cm long after removal.**

The patient underwent emergency removal of a foreign body from the left upper arm. Before the operation, a C-arm machine was used to locate the foreign body in the left upper arm and a transverse surgical incision was made. The foreign body was freed to the location position, and a guidewire about 1.8 cm long was seen during exploration (Figure 2). The guidewire was completely removed, which was confirmed by radiography.

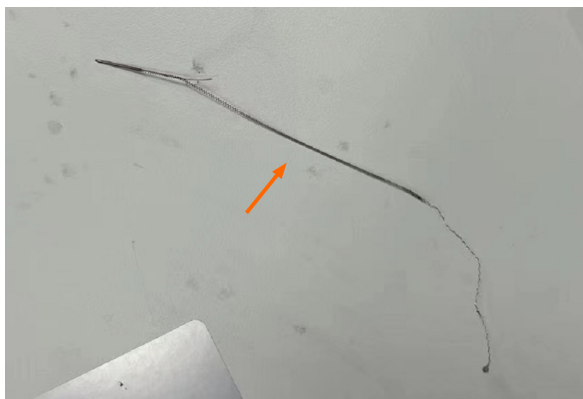
**Figure 4** Guidewire removed, about 1.8 cm long, with a bent head end.
